iS512-08, iS512-10G, iS325, GigaStorATX
and GSC-408

Version 2.5.1 Release Notes

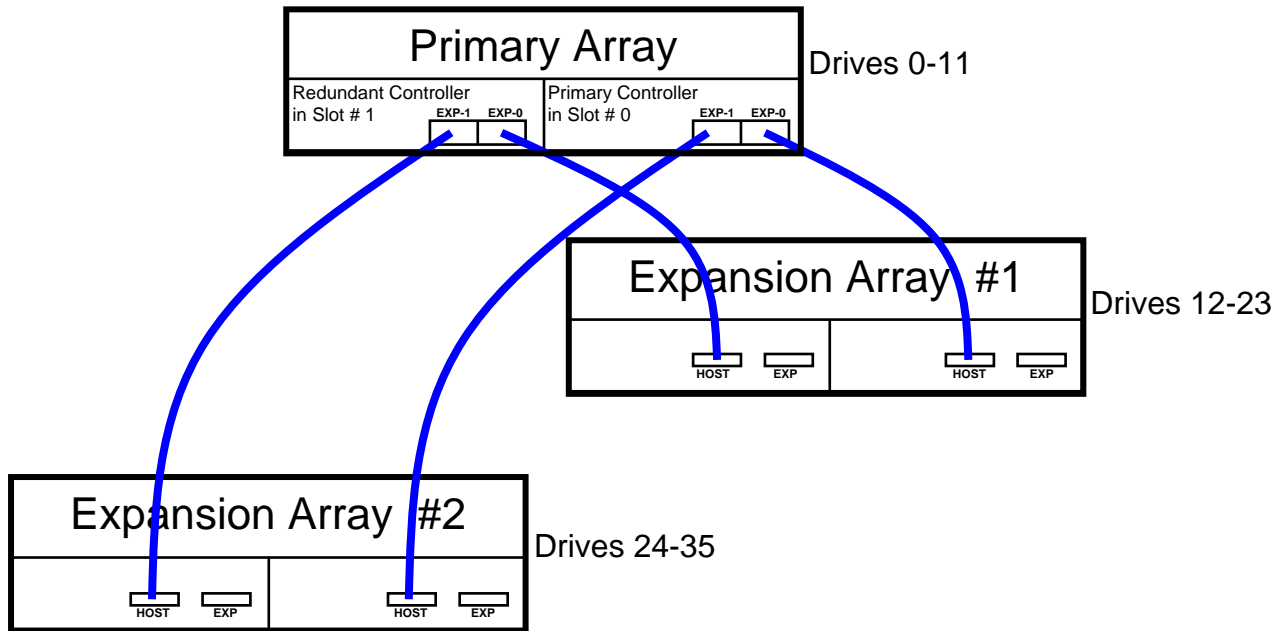
If your iS512 system uses one or two iS512-SX Expansion Arrays, each of the Expansion Arrays must also have dual I/O Modules, and there must be redundant connections between the Primary Array and the Expansion Array(s), as shown in the illustration below:

Field Upgrade Kits are available for single-controller iS512 systems to add a redundant controller to the Primary Array and a redundant I/O Module to the Expansion Array.
